ANNUAL REPORT FOR 2008

**UT Town Creek Mitigation Sites
Rowan County
TIP No. I-2511CA**

Prepared By:
Natural Environment Unit & Roadside Environmental Unit
North Carolina Department of Transportation
September 2008

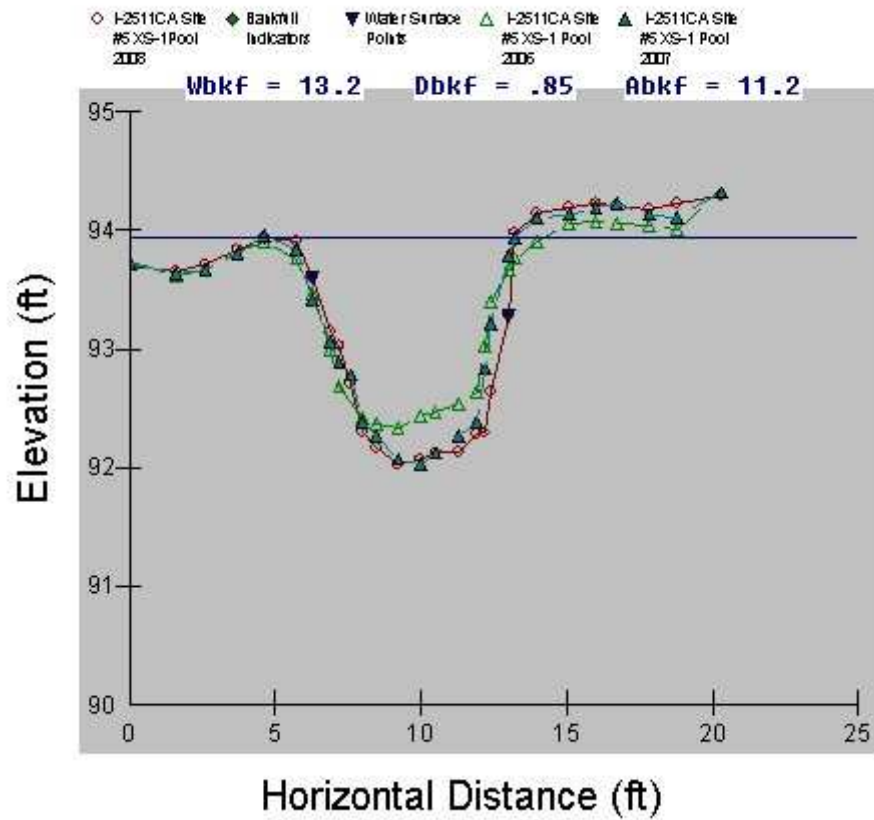
I-2511CA Site #5 XS-1 Pool

Site #5: Cross-Section #1 (Pool) Abbreviated Morphological Summary*					
	2006	2007	2008	2009	2010
Bankfull Cross Sectional Area (ft ²)	9.49	10.67	11.18		
Maximum Bankfull Depth (ft)	1.58	1.91	1.92		
Bankfull Mean Depth (ft)	0.68	0.82	0.85		
Bankfull Width (ft)	14.0	13.05	13.19

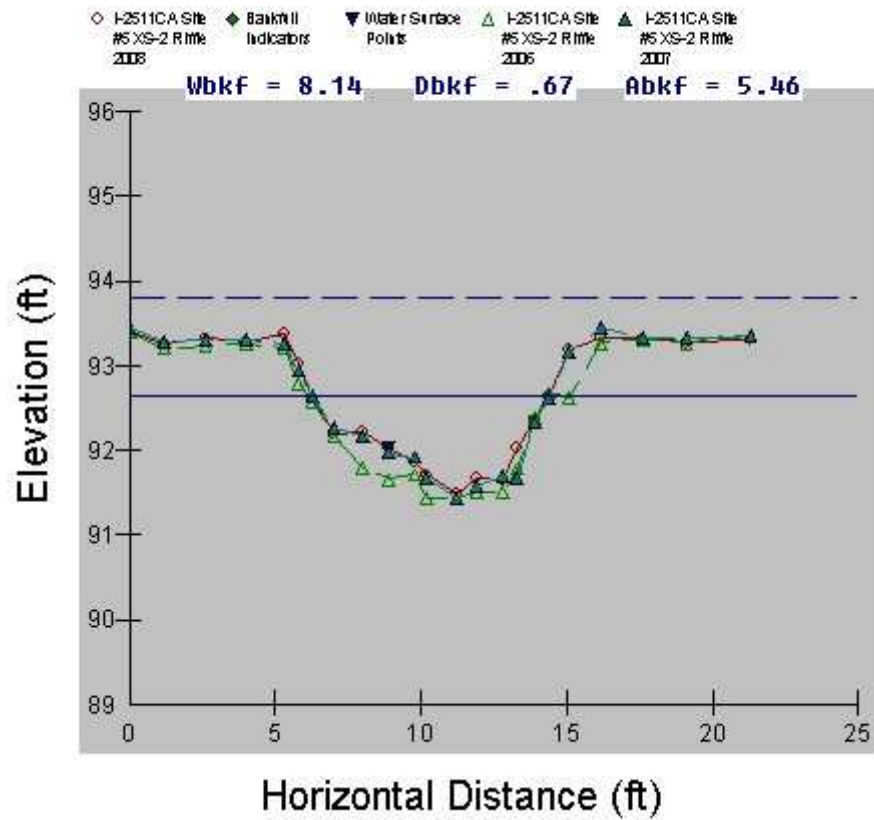
I-2511CA Site #5 XS-2 Riffle

Site #5: Cross-Section #2 (Riffle) Abbreviated Morphological Summary					
	2006	2007	2008	2009	2010
Bankfull Cross Sectional Area (ft ²)	7.24	5.51	5.46		
Maximum Bankfull Depth (ft)	1.24	1.17	1.16		
Width of the Floodprone Area (ft)	34.6	21.3	21.3		
Bankfull Mean Depth (ft)	0.79	0.69	0.67		
Width/Depth Ratio	11.57	11.65	12.15		
Entrenchment Ratio	3.79	2.65	2.62		
Bankfull Width (ft)	9.14	8.04	8.14

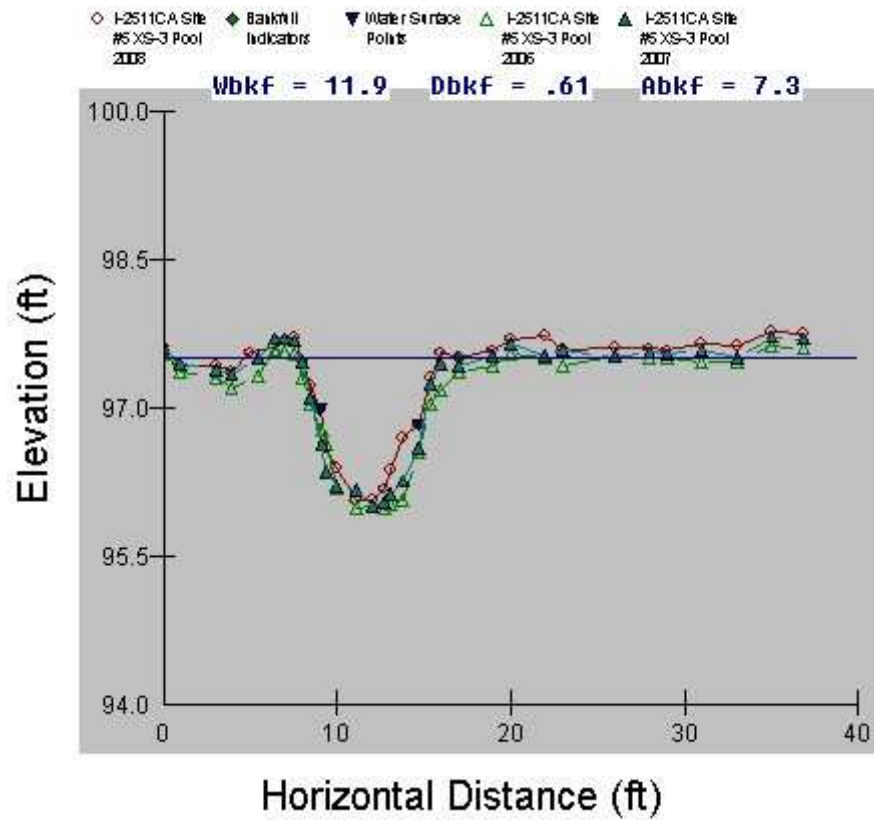
I-2511CA Site #5 XS-3 Pool

Site #5: Cross-Section #3 (Pool) Abbreviated Morphological Summary*					
	2006	2007	2008	2009	2010
Bankfull Cross Sectional Area (ft ²)	7.83	7.68	7.3		
Maximum Bankfull Depth (ft)	1.39	1.42	1.44		
Bankfull Mean Depth (ft)	0.86	0.72	0.61		
Bankfull Width (ft)	9.13	10.71	11.94

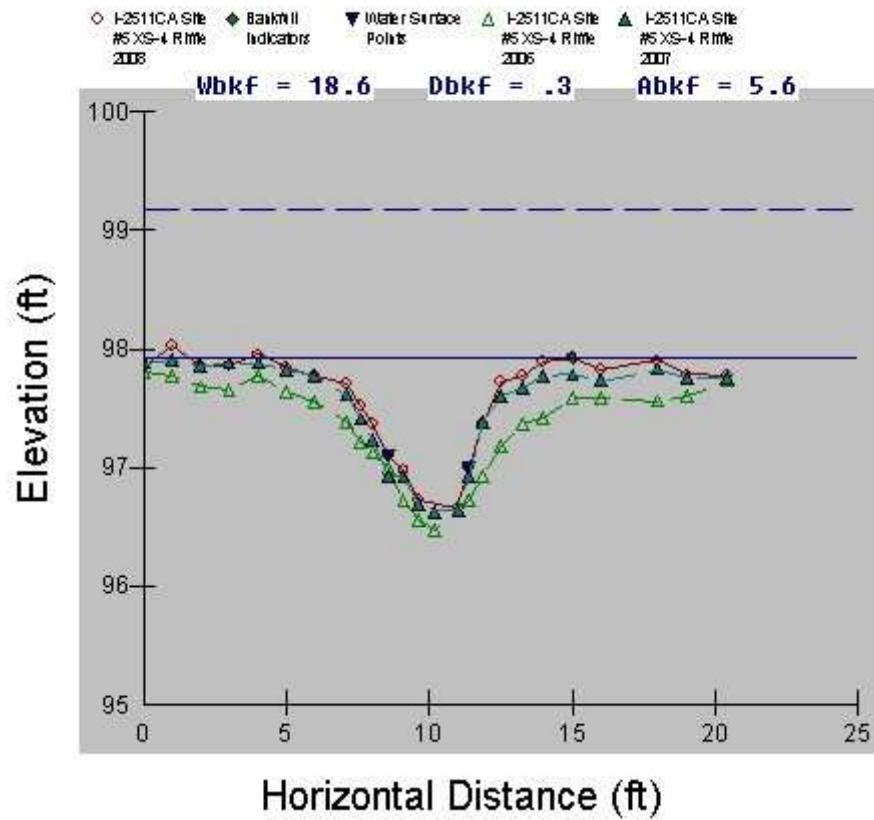
I-2511CA Site #5 XS-4 Riffle

Site #5: Cross-Section #4 (Riffle) Abbreviated Morphological Summary					
	2006	2007	2008	2009	2010
Bankfull Cross Sectional Area (ft ²)	4.65	4.48	5.06		
Maximum Bankfull Depth (ft)	1.12	1.15	1.26		
Width of the Floodprone Area (ft)	20.4	20.4	20.4		
Bankfull Mean Depth (ft)	0.50	0.35	0.3		
Width/Depth Ratio	19.27	37.09	25.89		
Entrenchment Ratio	2.16	1.57	1.79		
Bankfull Width (ft)	9.44	12.98	11.39

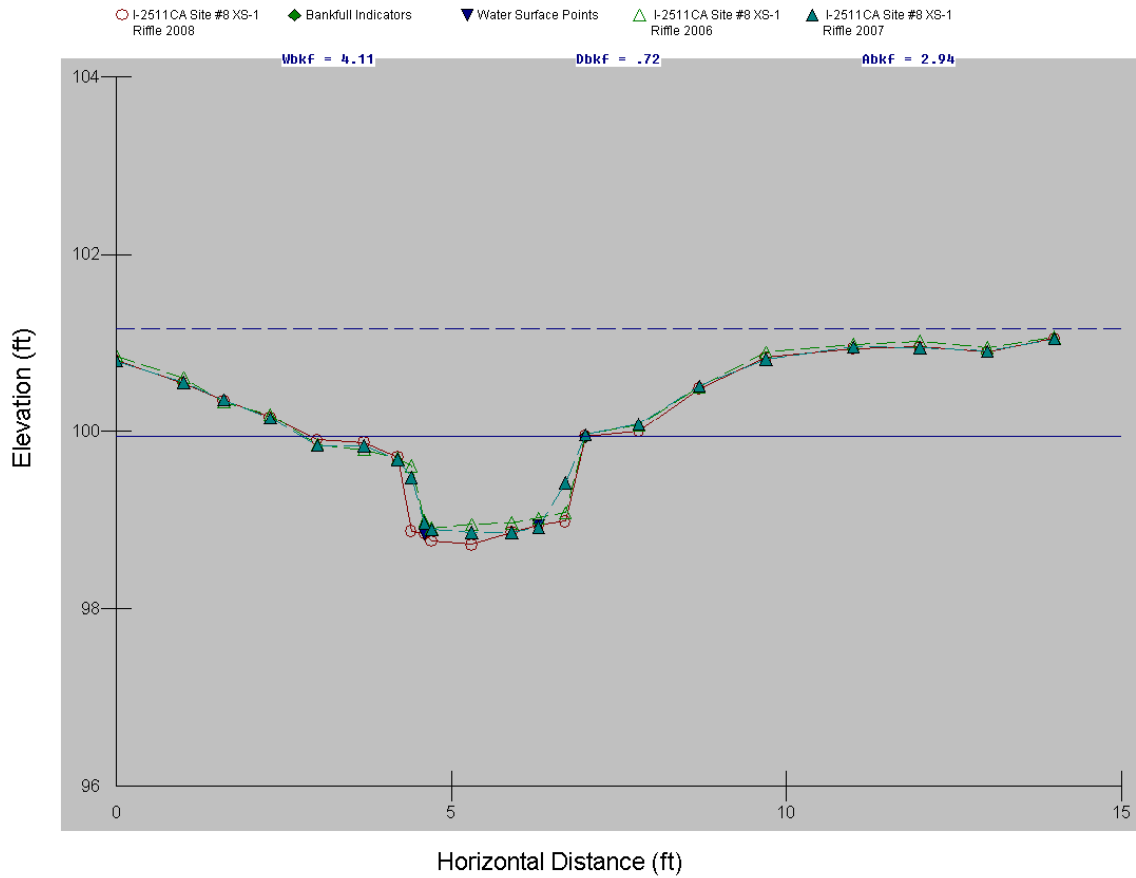
I-2511CA Site #8 XS-1 Riffle

Site #8: Cross-Section #1 (Riffle) Abbreviated Morphological Summary					
	2006	2007	2008	2009	2010
Bankfull Cross Sectional Area (ft ²)	2.62	2.67	2.94		
Maximum Bankfull Depth (ft)	1.05	1.10	1.22		
Width of the Floodprone Area (ft)	13.02	14	14		
Bankfull Mean Depth (ft)	0.62	0.62	0.72		
Width/Depth Ratio	6.82	6.89	5.71		
Entrenchment Ratio	3.08	3.28	3.41		
Bankfull Width (ft)	4.23	4.27	4.11

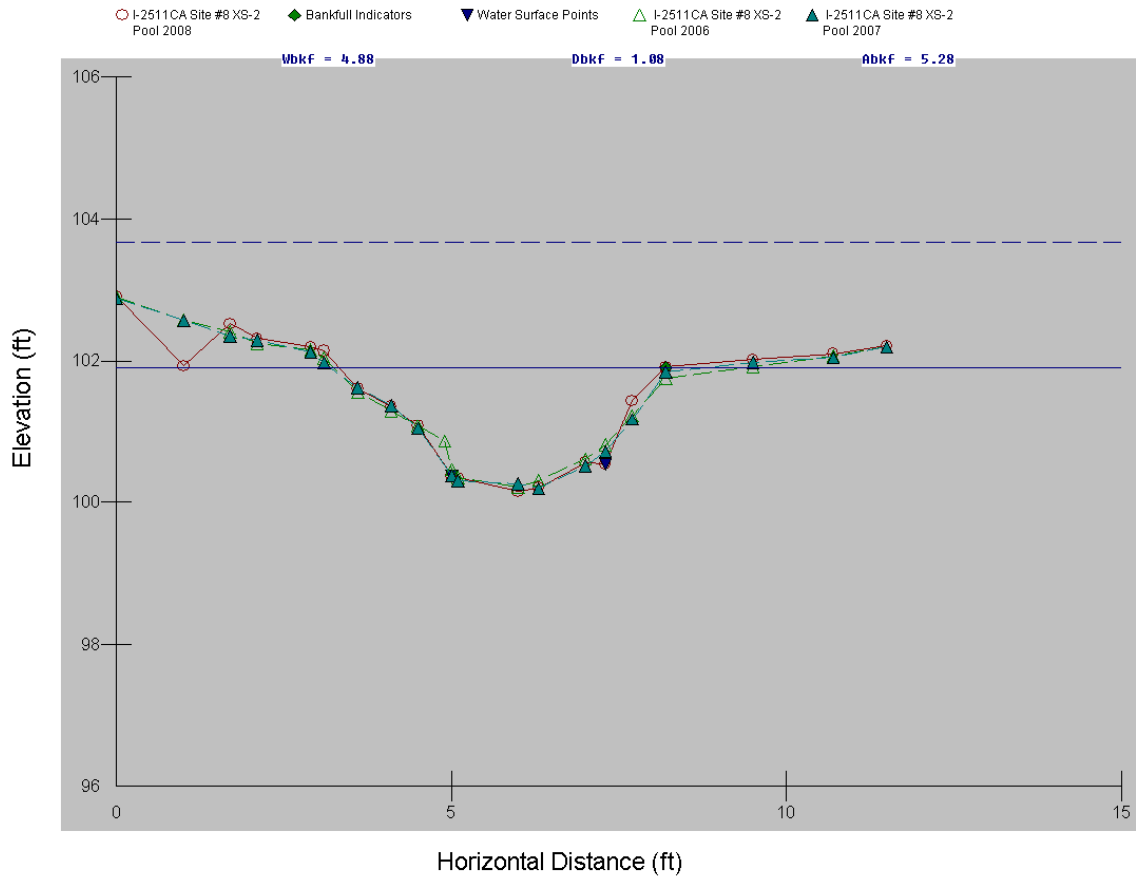
I-2511CA Site #8 XS-2 Pool

Site #8: Cross-Section #2 (Pool) Abbreviated Morphological Summary*					
	2006	2007	2008	2009	2010
Bankfull Cross Sectional Area (ft ²)	4.42	5.05	5.28		
Maximum Bankfull Depth (ft)	1.55	1.66	1.76		
Bankfull Mean Depth (ft)	0.92	1.03	1.08		
Bankfull Width (ft)	4.81	4.93	4.88
